Innovative Dewax Method Unlocks Potential for Investment Casters

Tom Branscomb
Buntrock Industries, Inc.

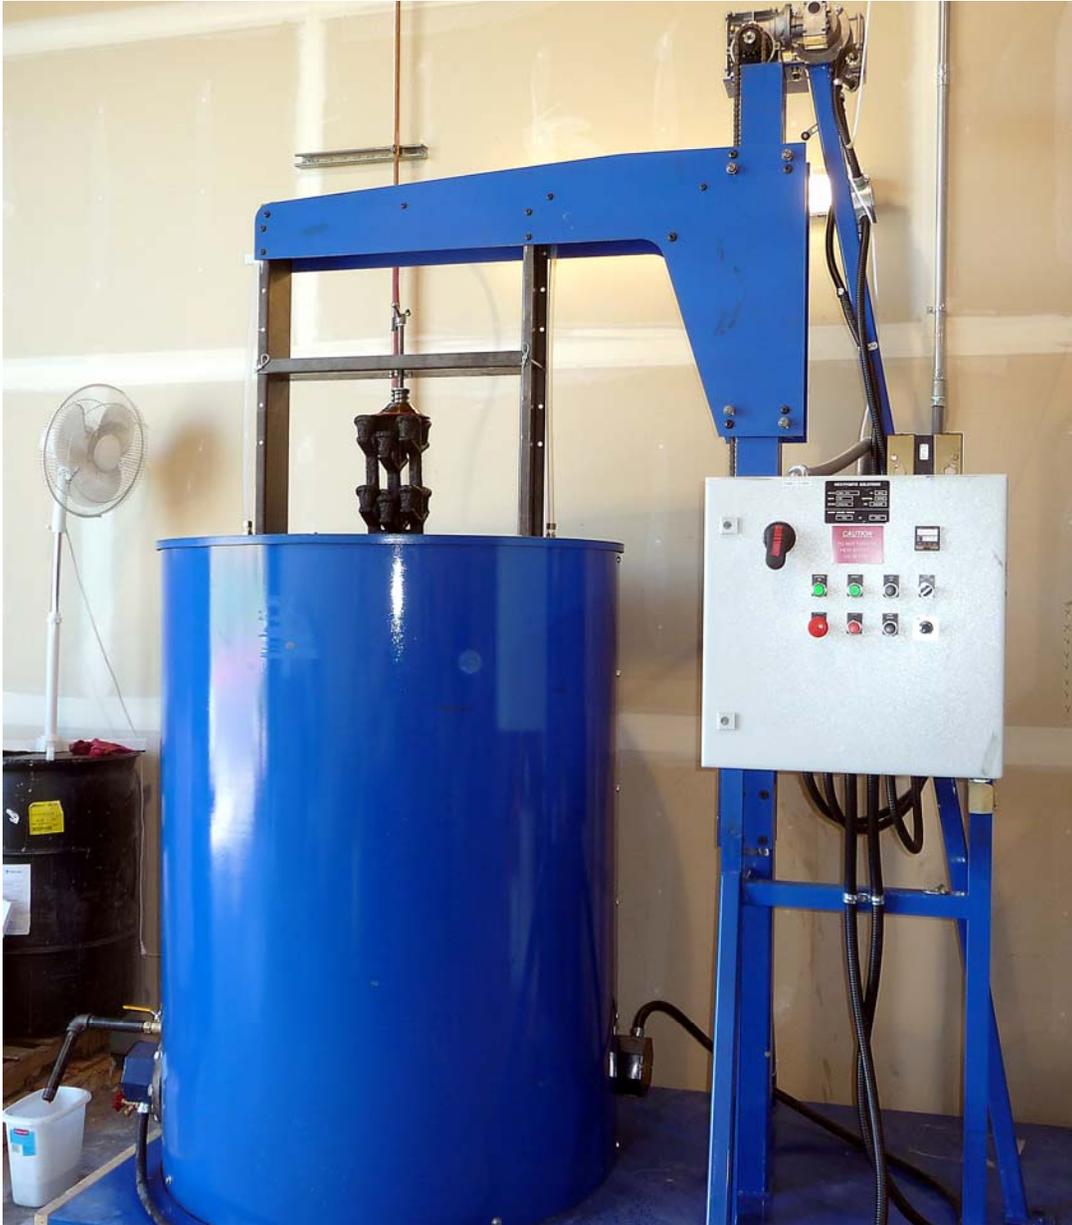
Figure 2 – Prototype directional dewax, hot oil dewax equipment

In order to fully demonstrate the feasibility of this new dewax technique, Buntrock Industries enlisted the help of Westpoint Solutions, Inc. to design and build a prototype machine for directional wax removal. Early work was done by lowering the shell into a hot oil bath. So, this method was used for the prototype equipment. Figure 2 shows the prototype machine. The temperature of the oil and the speed of lowering the shell into the oil are variable. A method of keeping the wax separate from the oil was incorporated into the design. At the bottom left of Figure 2, you can see the liquid wax outlet.

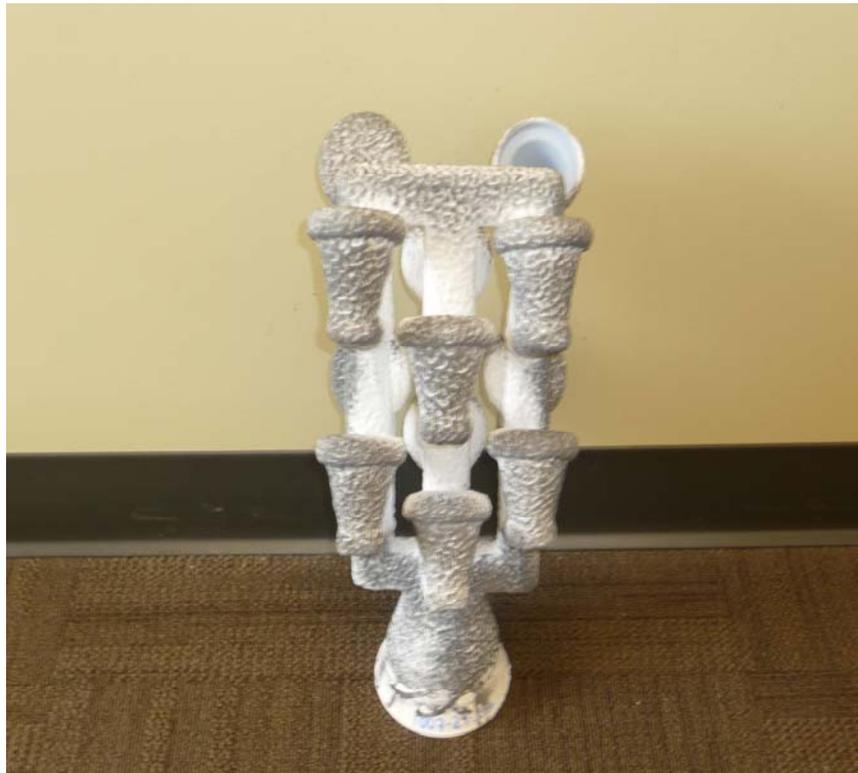
Figure 5 – Fused Silica shell after flash fire dewax.

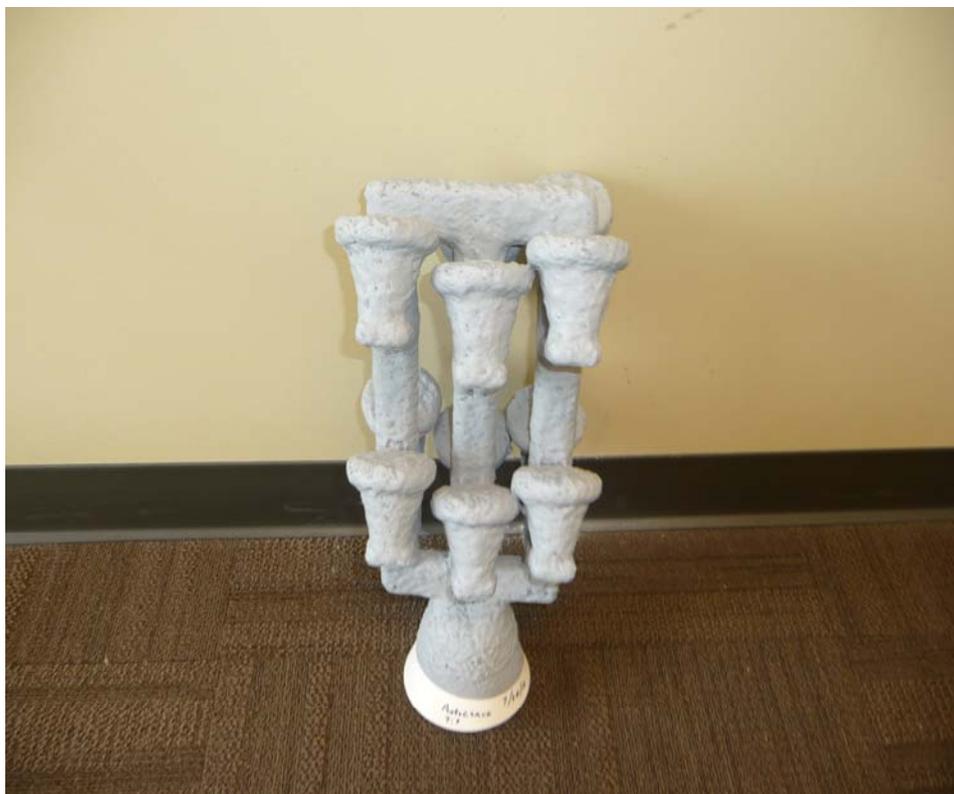
Figure 6 – Fibercoat 1109 shell after autoclave dewax.

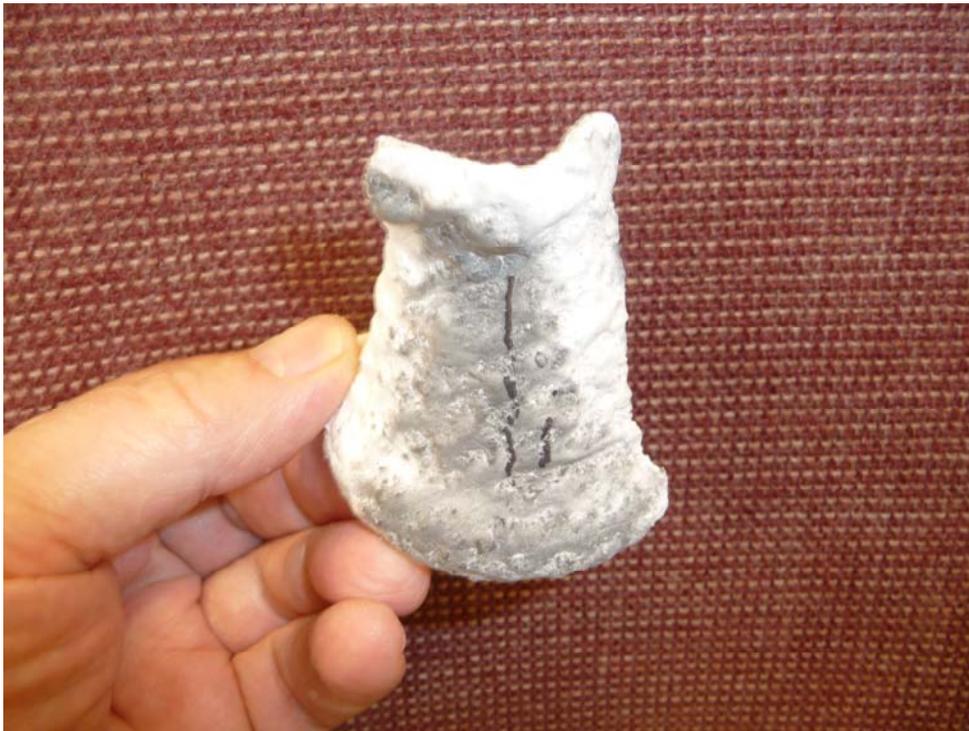
Figure 7 – Through wall crack on Fibercoat 1109 shell after flash fire dewax.

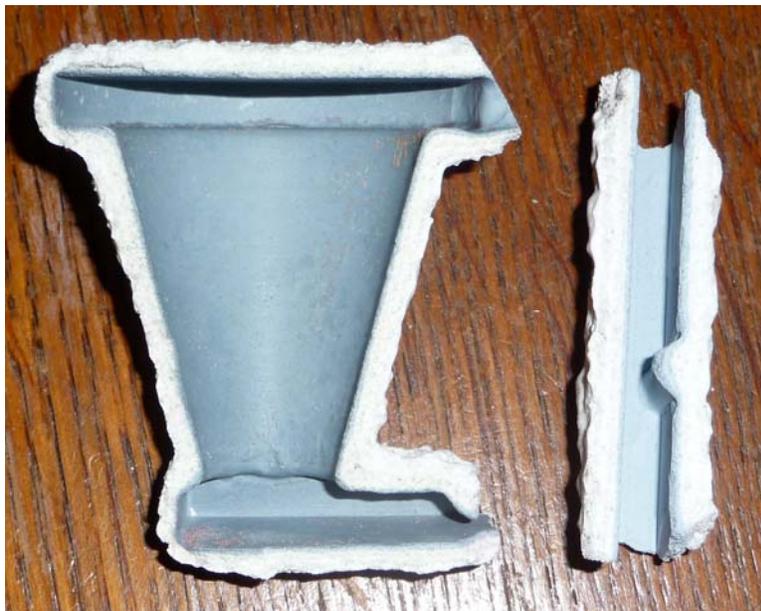
Figure 9 – Fused silica backup shell with 2 backup dips and restriction in gating.

Two more shells were made but only in the fused silica shell. One less dip was applied making the shell thinner. In addition the wax gate was restricted in size by about 50%. This restriction and thin shell are shown in Figure 9 below. One shell was dewaxed in the autoclave and one in the hot oil directional melting equipment.

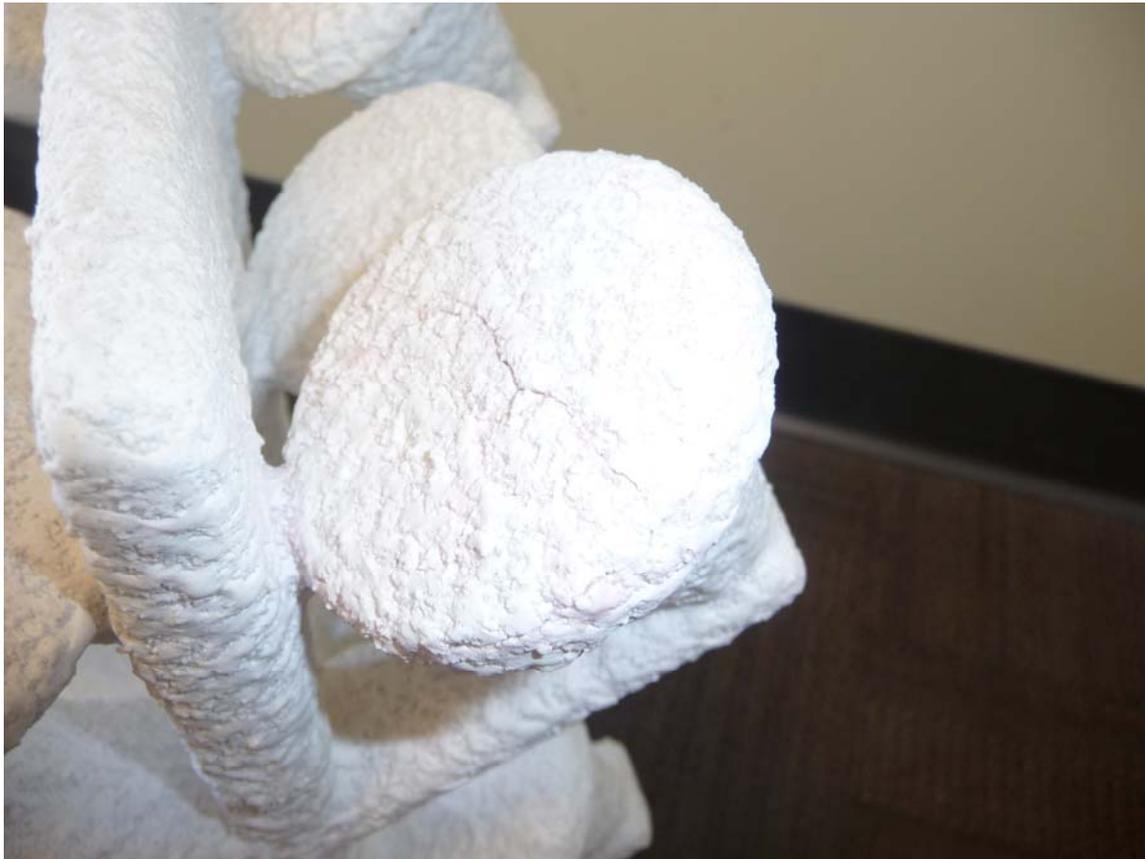
Figure 10 – Severely cracked fused silica thin shell, autoclave dewax, restricted gate.

The autoclaved fused silica shell had one cone that was severely cracked across and around the top. Shown in figure 10. All of the restricted gates of the autoclaved shell were cracked while there were only 2 cracked in the directional melting dewax method. Cracks in the gating are shown in Figure 11, but difficult to see except for the red wax bleeding through the shell.

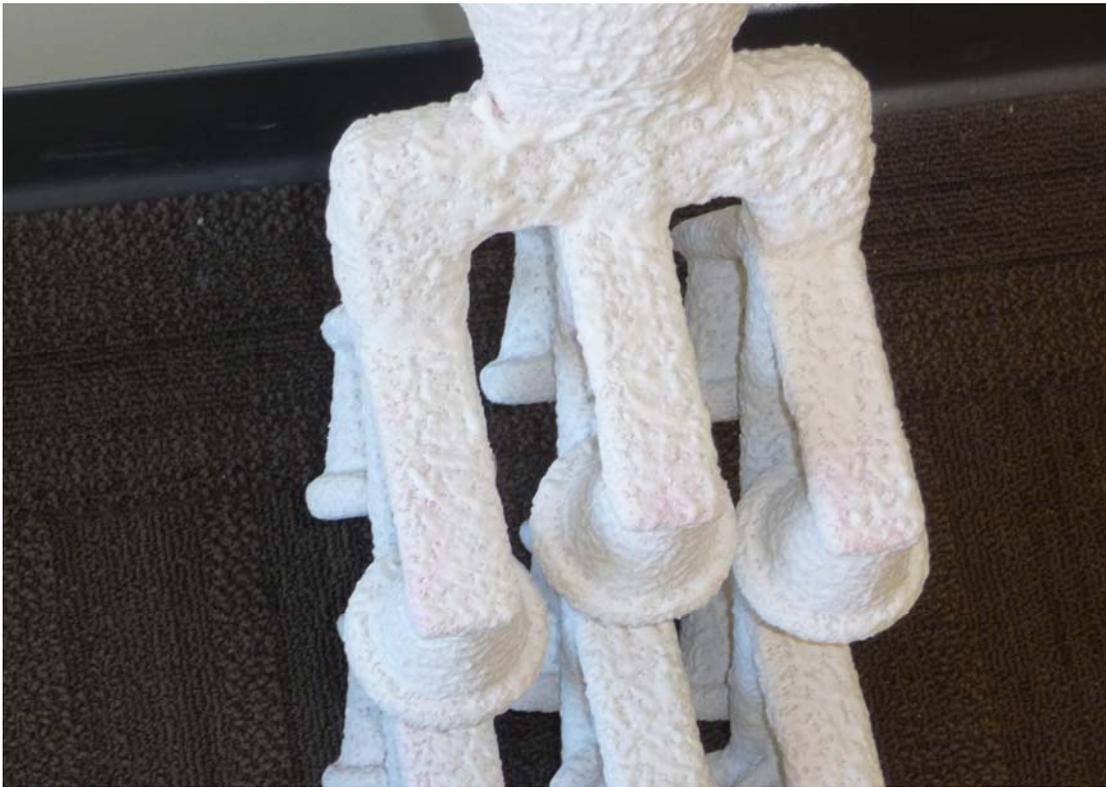
Figure 11 – Fused silica thin shell, autoclaved, restricted gating. All 12 gates cracked. Red wax bleeding through shell because of cracks.
